# Manhole Inspection Summary

Manhole # S59M\_\_006MH

Insp Date: **7/24/08 2:43 PM**

**Location** Address: **4520 odonnell st**

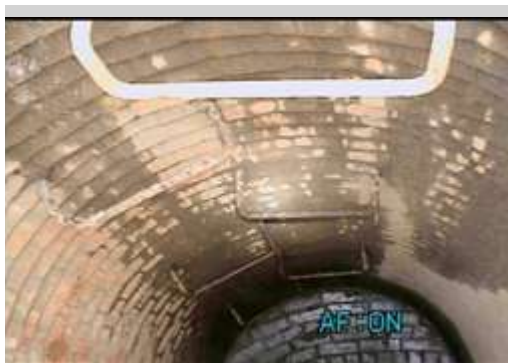
Defect 2

**Steps** Count: **6** Missing: **0** ☒ **Corroded**

steps

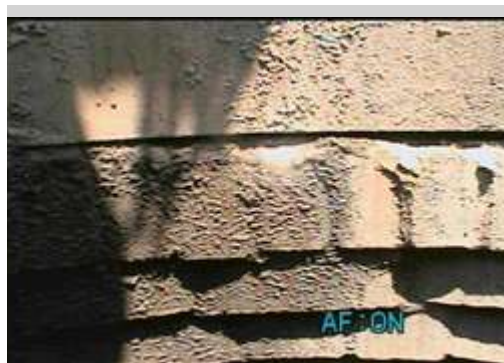
Defect 1

Condition: ☐ Sound ☐ Cracked ☐ Root Intrusion ☐ Loose Brick ☒ **Deteriorated**

Infiltration: ☐ None ☒ **Joint** ☐ Cracks ☐ Mortar ☐ Roots ☐ Wall

Chimney deteriorated  
, infiltration frame adj

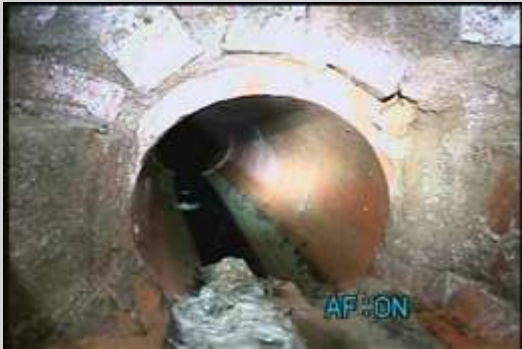
12 O'Clock Outflow

8 in. Circular Gravity Sewer  
Pipe Out @ 12 O'Clock

Invert Depth: 11.33 (ft.) Flow Characteristics: **Slow**

Infiltration: **None** Pipe Seal Cond: **Unknown**

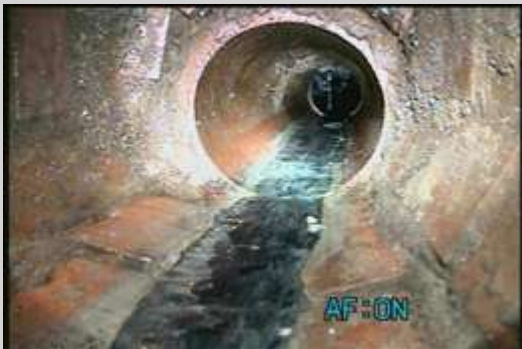
9 O'Clock Inflow

8 in. Circular Gravity Sewer  
Pipe In @ 9 O'Clock

Invert Depth: 11.16 (ft.) Flow Characteristics: **Slow**

Infiltration: **None** Pipe Seal Cond: **Unknown**
